ALTERNATIVE FUELS COMPATIBILITY WITH ARMY EQUIPMENT TESTING – AGED NIEDNER RIFTS CONDUIT TESTING

**INTERIM REPORT
TFLRF No. 426**

**by
Oliver P. Harrison
Southwest Research Institute®
Structural Engineering Department**

Contract No. W56HZV-09-C-0100 (WD15)

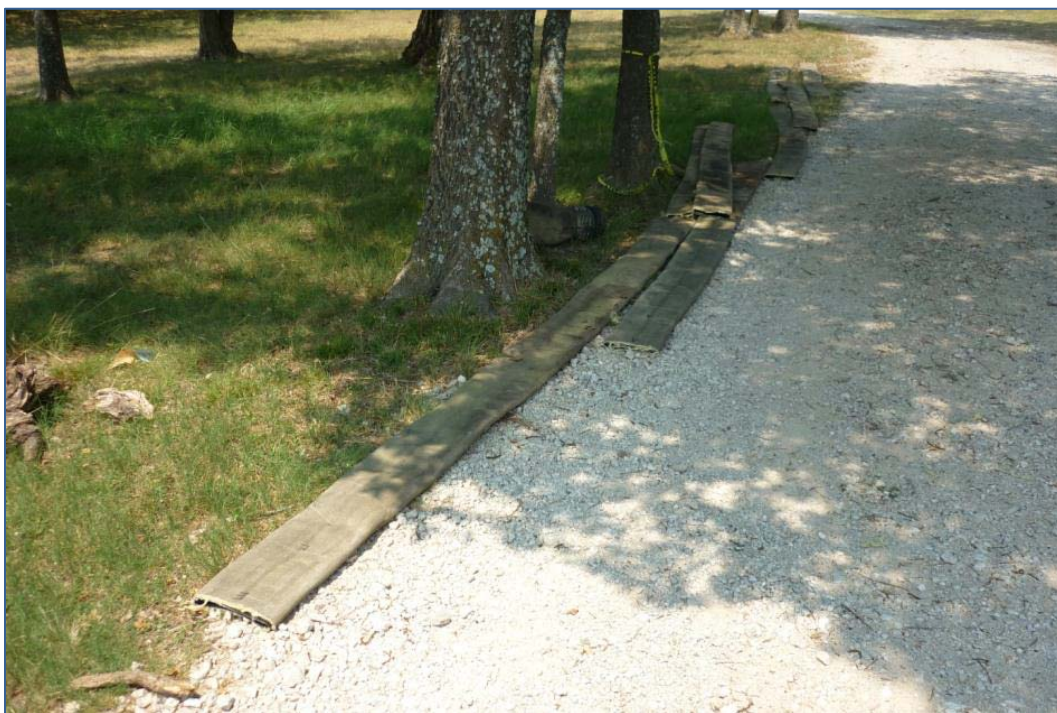
Figure 4. Specimens after Cutting

The eight specimens cut from the hose reel were measured and inspected for damage. When measuring the specimens approximately 3 hours after the specimens had been cut, it was noted that the outer jacket and the inner liner were no longer even. For this reason, measurements of both the jacket and liner were recorded for each specimen. These measurements are provided below in Table 1, along with notes of any damage present. It would appear, based on the original cut length of 15 feet, that the liners expanded. Figure 5 shows the specimens just after inspection. Figure 6 shows the ends of the stacked specimens, where the difference in length of the jackets and liners is clearly visible.

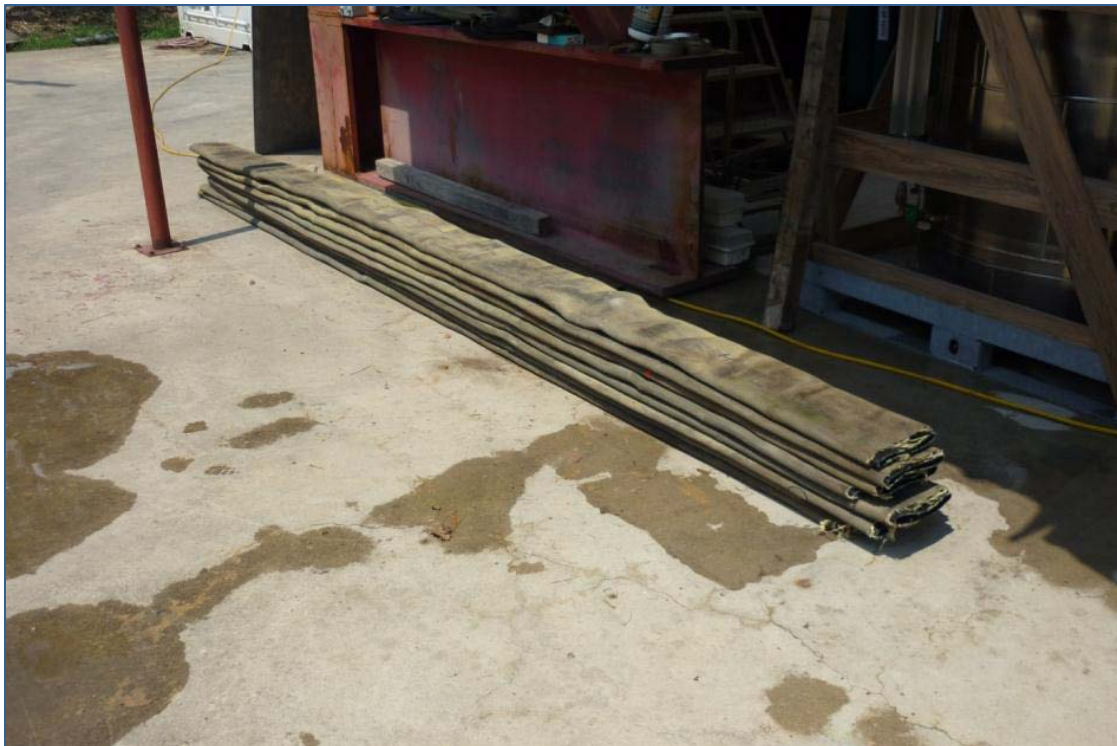
Figure 5. Hose Specimens After Inspection

The condition of all of the cut specimens was soiled but otherwise good, with the exception of specimens A and C. There was a small hole in the outer layer of the jacket of specimen A as shown in Figure 7. This was located 60 inches from one end of specimen A. The damage to specimen C was a less significant abrasion to the outer layer of the jacket located 9 inches from one end, shown in Figure 8. Neither of the anomalies were considered to be major damage that would exclude the specimens from testing; therefore, no actions were taken to repair or remove the damage. The notes from the specimen preparation and inspection are presented in Appendix A.

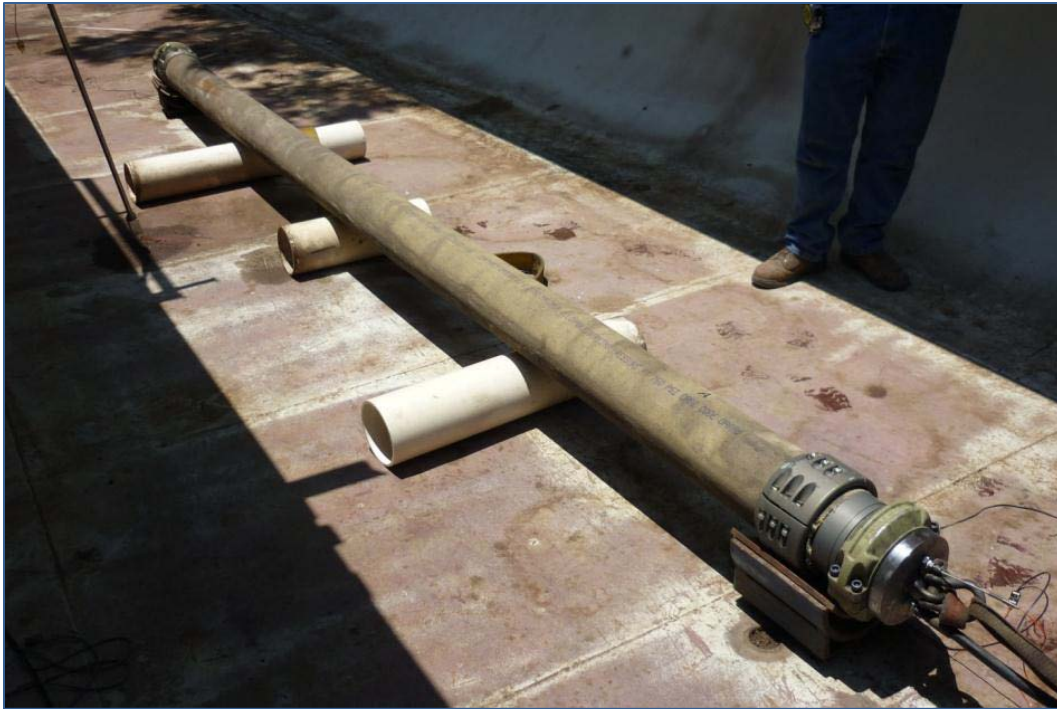
Figure 13. Specimen A Burst Testing Setup

Specimen	Length (inches) ¹	Burst Pressure (psig)	Failure Mode	Underwent Cyclic Testing
A	182 1/2	1504	Longitudinal tear of jacket and liner	No
B	180	1610	Longitudinal tear of jacket and liner	No
C	181 1/2	1886	Longitudinal tear of jacket and liner, small transverse tear of liner	No
D	181 1/2	1767	Longitudinal tear of jacket and liner	No
E	186 1/16	1324	Longitudinal tear of jacket and liner	Yes
F	184 1/2	1712	Longitudinal tear of jacket and liner	Yes
G	184 3/4	1680	Longitudinal tear of jacket and liner	Yes
H	187	1534	Longitudinal tear of jacket, blowout of liner	Yes
